TROUBLESHOOTING DOCUMENT

Low or no flow from either cold or hot line (tapware)

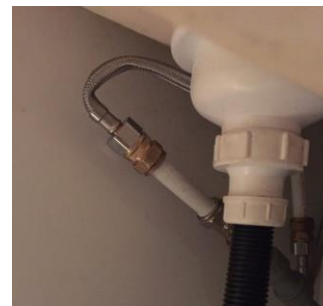
Taps with hot and cold flexible connectors check for any kinks in these flexible hoses and if pull out kitchen mixer check this flexible hose for kinks or weight in the wrong position (too low) this can also cause flow problems.

KINKED HOSE
