TROUBLESHOOTING DOCUMENT

Crazing Cracks: Bathroom sinks and Vanity basins

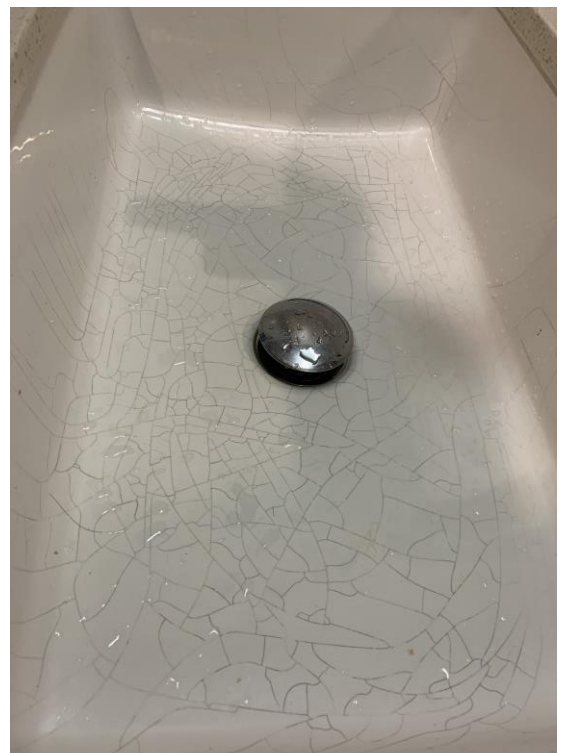
Miniature Hairline spider like cracks that appear on Vitreous China or Fine Fire Clay products

1. Thermal expansion: often in undermount basin that have been cemented to the solid surface, this cementing does not enable the basin to expand or contract under thermal movement so cracking / crazing can occur.
2. Thermal expansion when using over heated or boiling water this will also cause the V/C or FFC to crack or craze.
3. Water trapped in the overflow void of the basin, water can slowly leek under the glazing and cause cracking / crazing as the overflow void is unglazed water can penetrate the basin itself.
4. The waste fitting pinching into the vitreous china can cause undue stress and cause the basin to crack / craze, this can be determined by the pattern of the crazing which will be obvious as the crazing will start from the waste hole and spread out.

No remedies but the crazing is usually only cosmetic so, will not leak

The advice is to replace the basin / vanity at the customers earliest convenience
