## TROUBLESHOOTING DOCUMENT

Crazing in shower acrylic liners, shower trays and wastes.

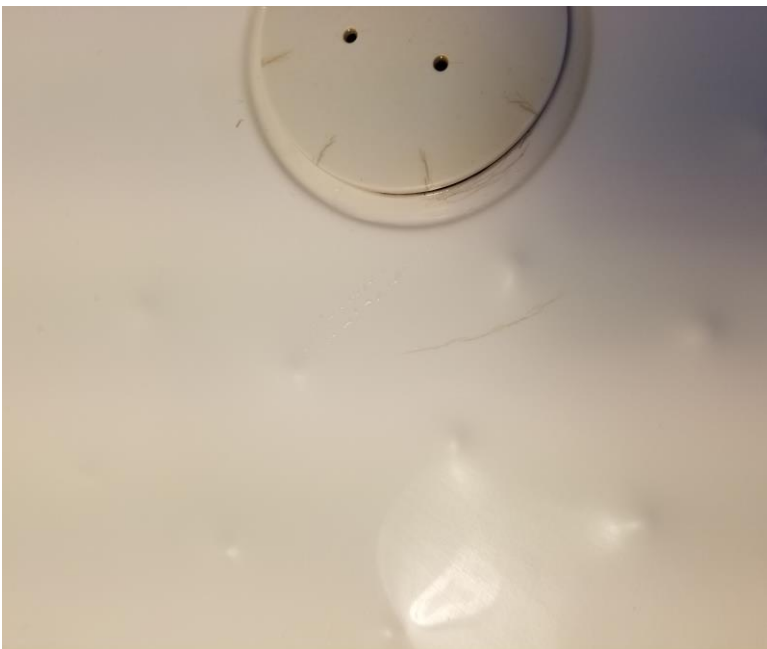
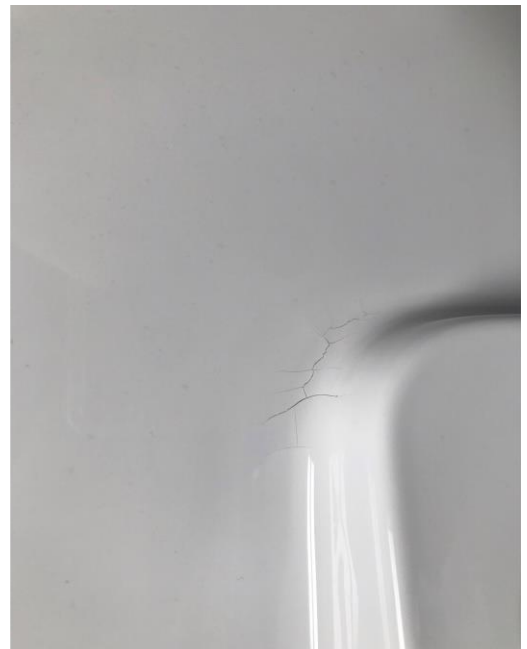
Crazing or splits along the folds of the acrylic liner or on the shower tray is caused by a chemical reaction usually from non-suitable cleaners being used or a cleaning product being left on for too long. This chemical reaction will cause the acrylic to shrink to the point where it begins to tear.

Robertson liners, trays and wastes come from different suppliers using different resins so if crazing is occurring on multiple products, then a chemical reaction has caused the issue.

The damages caused by this chemical reaction can be repaired using Mend A Bath to a finish that will not be noticeable

1. This is not covered under warranty
2. If the same cleaners are continued to be used this crazing will re-occur
