## TROUBLESHOOTING DOCUMENT

### DISPOSITION OF PROBLEM

#### **Limescale (calcium) accumulation:**

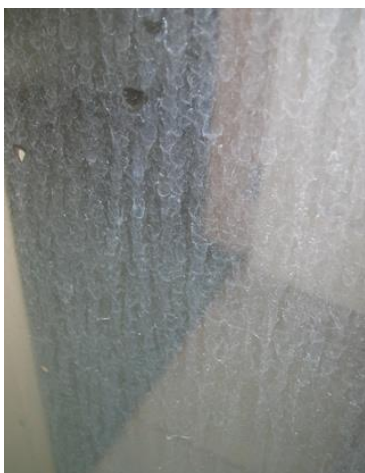
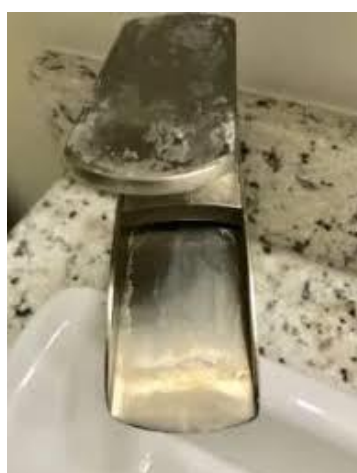
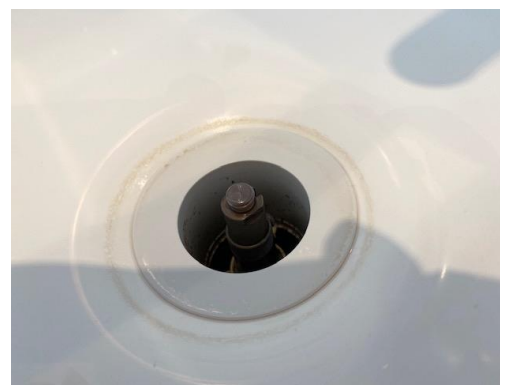
Over sometimes a short period of time, limescale, a hard, chalky deposit of calcium carbonate can accumulate on tapware and shower glass or around the basin / bath waste hole and can accumulate within the cartridge or the aerator of the tap slowing the flow of water.

The root cause of the problem is your town supply of water.

In New Zealand, our municipal water supplies contain a variety of minerals, one of which is likely to be calcium carbonate.

Calcium carbonate is far more likely to be present in hard water areas.

Make a solution of equal quantities of white vinegar and warm water. Dip a cloth into the mixture and use it to clean up your taps. In case of a stubborn buildup of limescale, you can wrap a cloth dipped in the vinegar solution and leave it for an hour before washing it clean. Following this, rinse and dry the fixture as vinegar is mildly acidic and can damage the finish if left on.

With a ring around a basin / bath waste on vitreous China Brass Brite can be used and polished off with a no abrasive pad.

Be extra careful with coloured tapware or concrete products as some colour can be a painted finish (tapware) or pigmented colour (concrete products) and will require extra care.

NB: the only permanent fix for hard water (mineral build up) is to install a water softening device that filters the water for the entire home.

A Water Softener is a filtration system that works to remove high concentrations of calcium and magnesium that cause hard water. When water flows through a Water Softener, the system filters out these hard water minerals and the softened water then leaves the water softening system to flow through plumbing.
